## Studying What Went Wrong

Written by Kate Kunkel

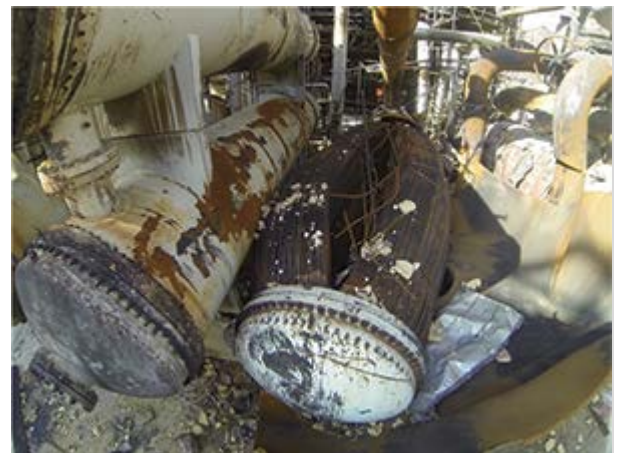
The incident occurred during non-routine operational activities that introduced heat to the reboiler, which was offline and isolated from its pressure relief device. The heat increased the temperature of a liquid propane mixture confined within the reboiler, resulting in a dramatic pressure rise within the vessel. The reboiler shell ruptured catastrophically, causing a boiling liquid expanding vapor explosion and fire (Figure 1).

The CSB investigation revealed deficiencies in the plant's safety culture that resulted (among other things) in failure to manage appropriately or review effectively two significant changes. These changes introduced new hazards involving the reboiler that ruptured. The first was installation of block valves that could isolate the reboiler from its protective pressure relief device. The second was the administrative controls Williams relied upon to control the position (open or closed) of those block valves.

Figure 1. Post-blast photograph of the heat exchanger that ruptured catastrophically, causing extensive explosion and fire damage to the plant.

The CSB analysis concluded that a risk-reduction strategy known as the "hierarchy of controls" should have been in place to effectively evaluate and select safeguards to control process hazards. Using this strategy could have resulted in Williams choosing to install a pressure relief valve on the reboiler that ultimately ruptured instead of relying on a locked open block valve to provide an open path to pressure relief, a less-reliable solution because of potential human errors.

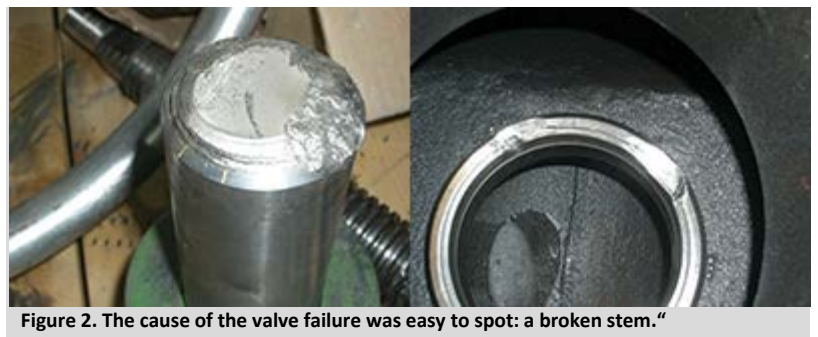
Once we disassembled the valve it was obvious that a broken stem had caused the valve to fail,” the company said (Figure 2).

When the valve stem was in the open position (back-seated position), the end-user-installed gear operator applied so much force in the open position that it exceeded the yield strength the 410 stainless-steel stem could take.

Figure 2. The cause of the valve failure was easy to spot: a broken stem.“

“This caused the stem to break at the transition point between the packing area and back seat area of the stem,” the company reported.

The end-user-installed gear operator also had a torque/thrust rating that exceeded that for which the valve was rated. The valve was scrapped because of the broken stem and the damage that it caused to the globe and body seat. The end-user then purchased a new replacement valve with a properly sized gear operator.

**Lesson learned:** When a gear operator or an actuator is needed, it is important to size it according to the valve on which it will be used.

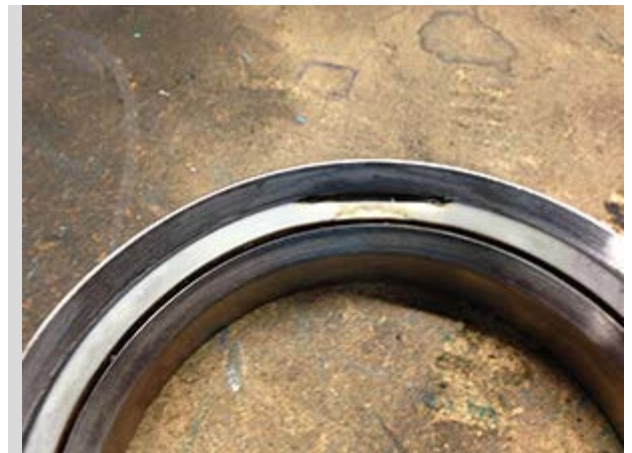
Universe Machine performed a hydrotest at its facility in accordance with American Petroleum Institute 6D (API-6D); the valve failed a seat leakage test on both sides of the valve. The repair team disassembled the valve to inspect for the cause and found that the upstream and downstream seats both had damage that correlated to the valve being used for throttling or the valve being not fully closed when installed on site.

If looking down the valve bore with the stem at the 12 o'clock position, the damages found on the seats were 180 degrees from each other at the 3 o'clock on one and the 9 o'clock on the second," the company reported. This correlated to the valve being used in a partially open position. Figure 3 shows the damage found on one of the seats—the other seat had the same damage in the polymer seat inserts.

Figure 3. The product flowing through the valve was hitting against the seat face inserts when the valve was in a partially open position, which then caused a seat leak path when the valve was fully closed."

Universe Machine machined and installed new seat inserts and assembled the valve, ensuring that the stops on the valve gear operator were set correctly and that the inside bore of the ball was in proper alignment with the inside bore of the valve and seats.

**Lesson learned:** Don't use a ball valve in a partly open position to control flow and make sure to use valves only in processes the supplier warranties cover.
